Modell Ost

BUILD NOTE

Valve Gear Rebuild of Alan Gibson L and B Manning Wardle 2-6-2 in On14 1/43 scale

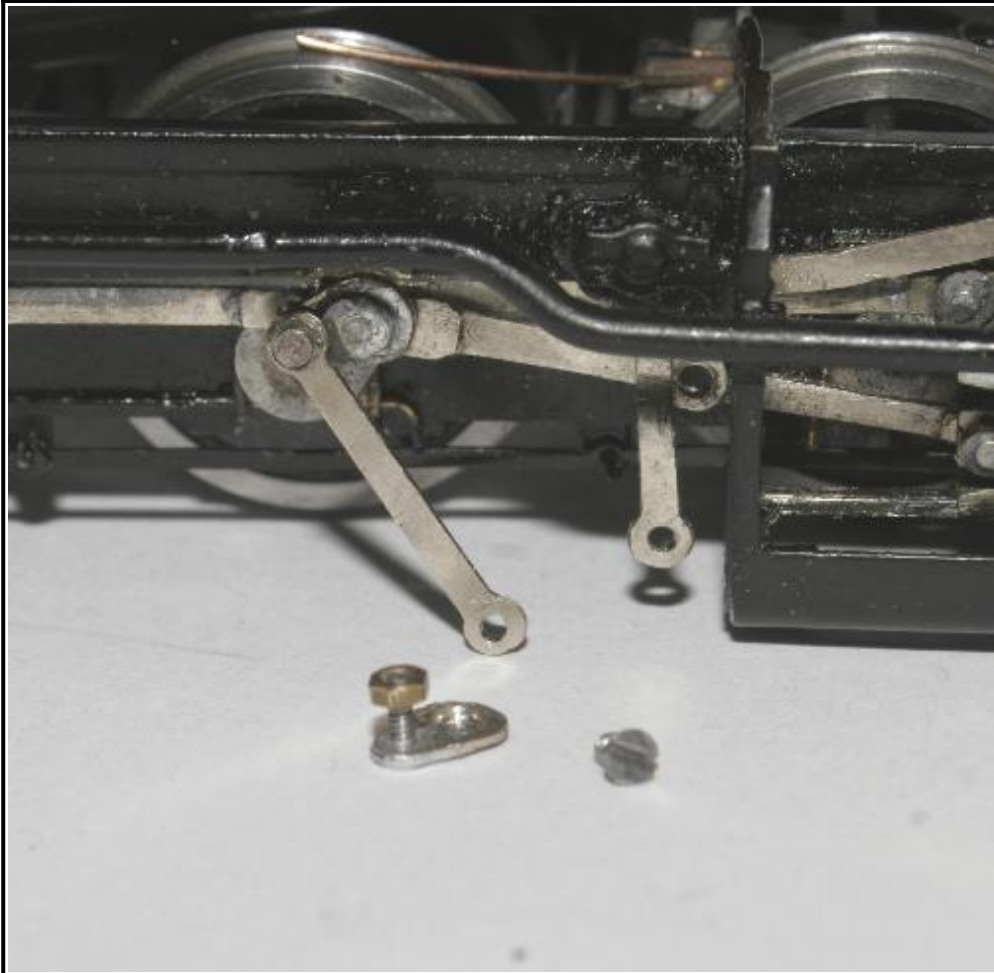
Parts laid out preparatory to assembly - first attempt. The correcting link now also has a 14 BA screw soldered in from behind to replace the (second) riveted pin that formerly held the vibrating lever and eccentric rod.

It is not a very elegant solution, as there is still a little too much 'wobble' around the countersunk screw head for my liking. In the process, the riveted pin securing the vibrating lever and eccentric rod managed to come out - which in hindsight made the job a little easier than it might have been - and had to be replaced with a 14 BA screw soldered in from the rear.

Using a screw meant that the rods and levers could be secured using a 14 BA nut, rather than a soldered on collar. I now use a Loctite 'lock and seal' compound for jobs like this, applied with the end of a pin to the inside of the nut. Getting such small nuts on can be a bit fraught, so I now pick them up first in the end of a pin vice, which is then twirled between the fingers to start the nut on its thread.

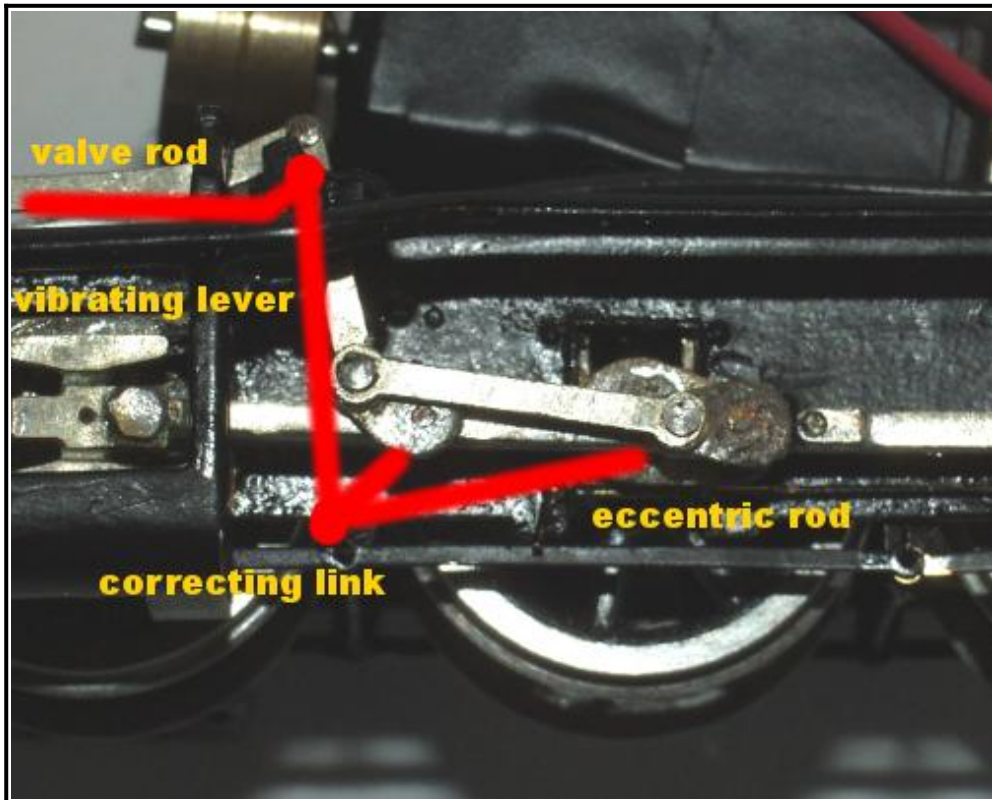
All went well until I ran the chassis on its side as a final check before refitting the body, when the original problem of the Joy gear jamming itself up against the motion plate manifested itself again several times. Being a bit of a doubting Thomas, I did check on the other - untouched - side, just to see whether I had missed something. But no, sure enough, it proved possible to replicate the same bind on the LH side of the engine, although there is more 'stick-tion' here, which seemed to be stopping the valve gear from moving too far out of kilter.

Here's the problem. This is the LH side, which I have not touched. The lines in red indicate the correct position of the Joy gear. Gear has been artificially moved to its 'foul' position. Note how the correcting link has swung 'upwards' around its connecting rod pivot, taking the eccentric link, vibrating lever (the vertical rod in the picture) all up with it.

This seemed only to take place if the model was held upside down or on its side, and if the various links unfortunately all happen to have stopped at the 'sweet spot' where gravity caused the swing to take place - which is of course in the 'downwards' direction. ('Upwards' in the image above - still with me? Good...)

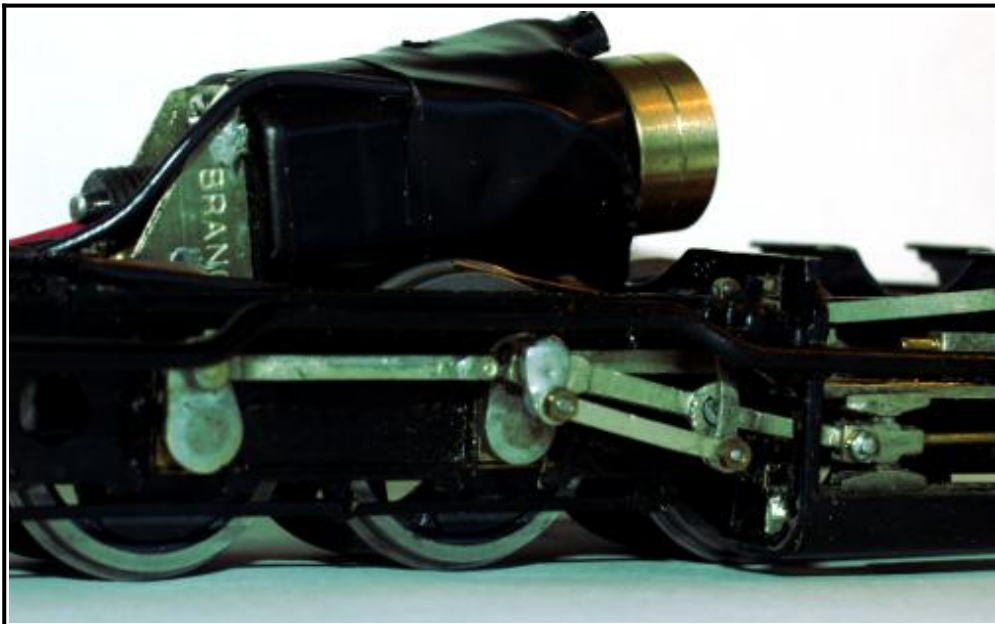
To cap it all, further investigation revealed that the eccentric crank on the driving wheel axle flycrank had started to shift on the RH crankpin. Thinking that the builder had used a 12 BA screw set in from the rear of the flycrank, and fearing the worst, I carefully unscrewed the eccentric anti-clockwise, all the while 'feeling' for any sign that the solder on the back face of the crank might be letting go rather than that on the eccentric. However, I needn't have worried, as in the event it turned out to be just a simple pin.

New return crank, modified correcting link, 14 BA nuts secured with Loctite, all assembled on the model and awaiting return to the client.

So, make up - another - eccentric crank, this time from 1mm thick brass plate, with the face filed down to give a raised area for the eccentric rod eye to sit upon, clear of any stray solder, drilled 1mm for the pin bore, and then drilled and tapped for a 14 BA screw in like manner as when dealing with the correcting link. Yes I know, it is certainly not Good Practice to have screw threads as bearing shafts...but needs must when the Devil drives, and when the 'ole starts to get smaller than 0.80 of a millimeter, he's driving exceedingly hard in my book! By the way, I drill and tap small components like these whilst they are 'on the bar' as it were, leaving the final shaping and cutting off until last. One, they are easier to hold, and two, if you do the 'mission-critical stuff early on, there is less time lost if things go pear shaped and you need to start all over.

Anyway, an hour or so later, everything was ready for the soldering iron, and the new return crank popped on. After having put the two 14 BA nuts on for the eccentric rod, I moved the wheels through a couple of complete revolutions by hand backwards and forwards to check that everything was still OK - with the chassis in its normal running orientation - though because of the 'braking effect' of the current pick-ups, checking for binding had to be done by 'wiggling' each link stage by stage with a pair of tweezers.

All told, the correcting link had to come off and go back on again I think at least four or five times before the motion could be got to turn freely enough for my liking. So start to finish, there is probably something like seven to nine hours worth of work in a seemingly simple job like this. And that does not include making good with the paintbrush after either.
