Modell Ost

BUILD NOTE

Valve Gear Rebuild of Alan Gibson L and B Manning Wardle 2-6-2 in On14 1/43 scale

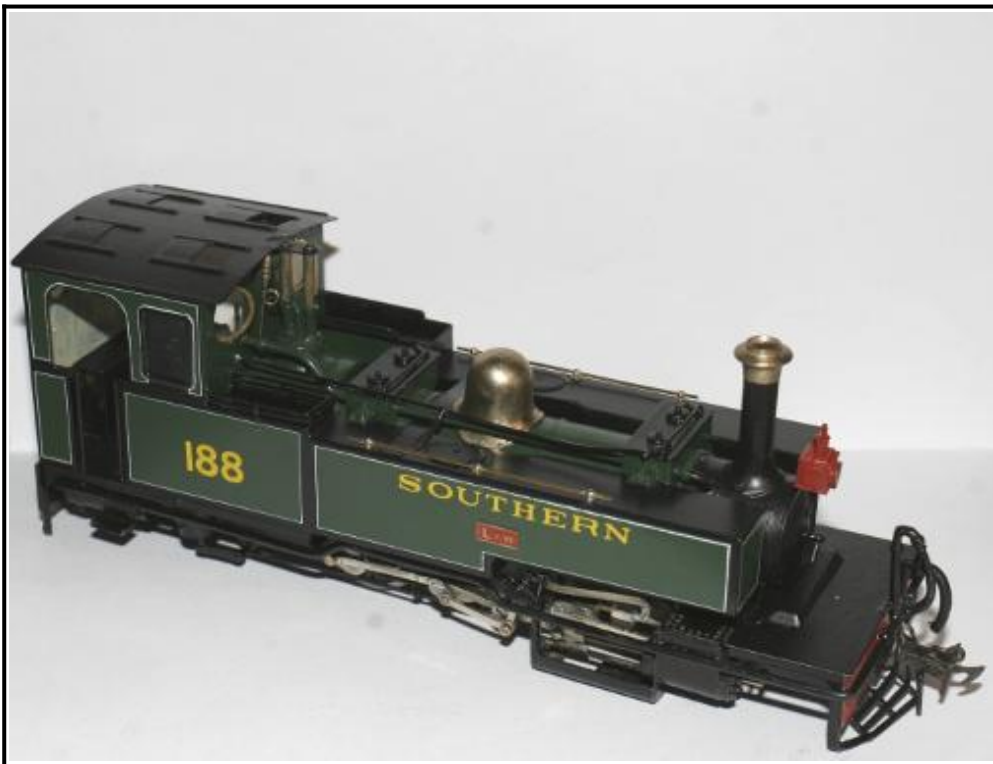
The Gibson 7mm L and B 2-6-2, finished in Southern livery.

The problem with this particular model was its Joy valve gear. Or more accurately, that the pin securing the eccentric rod and vibrating lever to the correcting link had come adrift, jamming up the motion in the process. On closer examination, the aforementioned pin was a 14 BA screw, put in from behind the coupling rod, and then soldered over on the outside to secure it in place, with the rest of the motion then built up on top of that. The technique relies on interposing bits of paper between the various components that are then torn away afterwards, to both provide running clearance, and also to prevent the solder from creeping along the pivot and siezing everything solid.

As I wanted to disturb as little as possible of what was already there, I decided that given that there was still enough meat left in the coupling rod eye for a 12 BA thread, to replace the soldered in correcting link pin with a shouldered screw, set to sit flush with the surface of the correcting link. The shouldered screw was turned up on the little lathe, but I freely admit came out 'just right' very much more by accident rather than any skill on my part.
